**INSPECTION REPORT: BULK ASBESTOS SURVEY  
SAN YSIDRO BORDER CROSSING  
BUILDING CA0588  
720 E. SAN YSIDRO  
SAN DIEGO, CA 92115**

**GSA Contract No.: GS-09P-07-NQ-M-0023**

**SCA Project No.: G-8452**

**JUNE 2007**

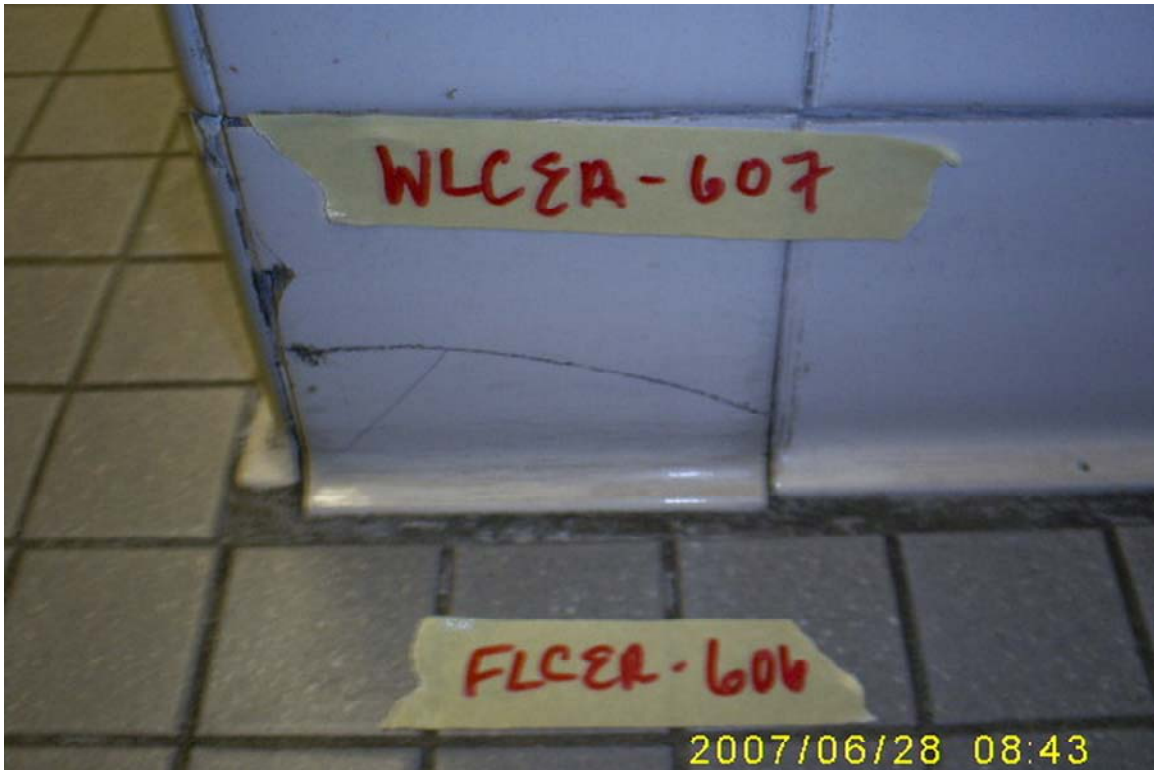
*Above: HA FLCER-606 & WLCER-607*

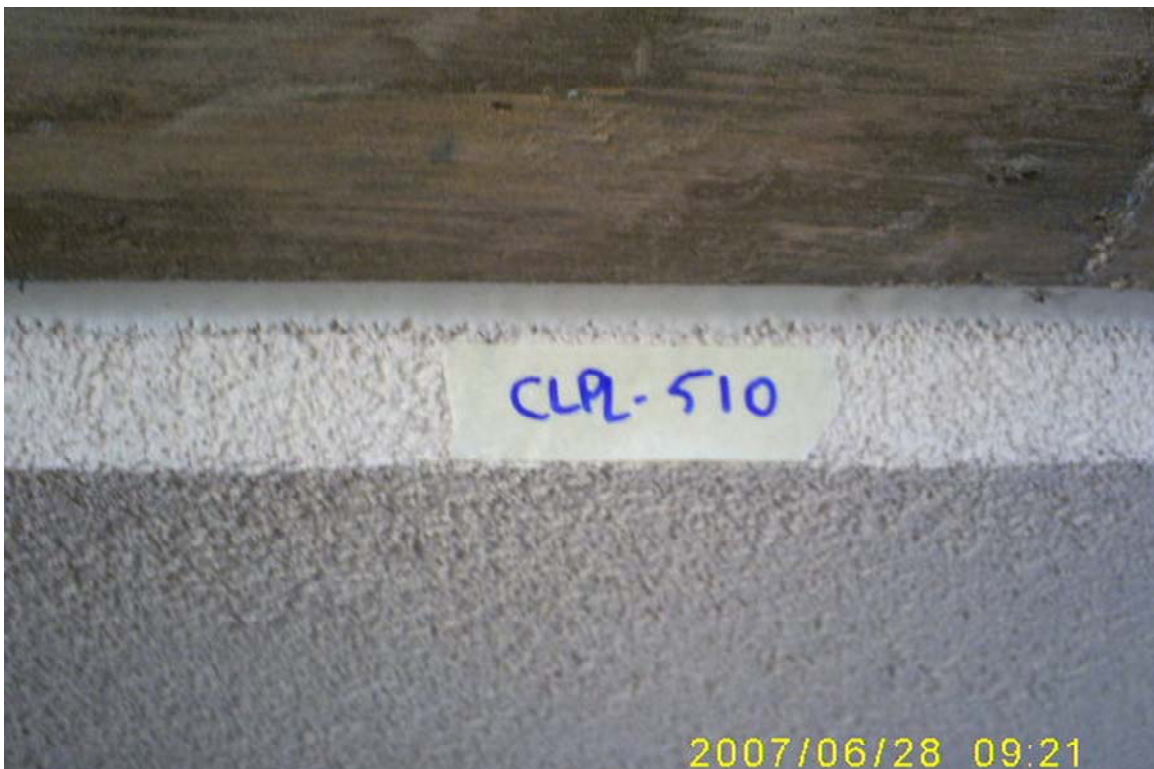
*Below: HA CLPL-510*

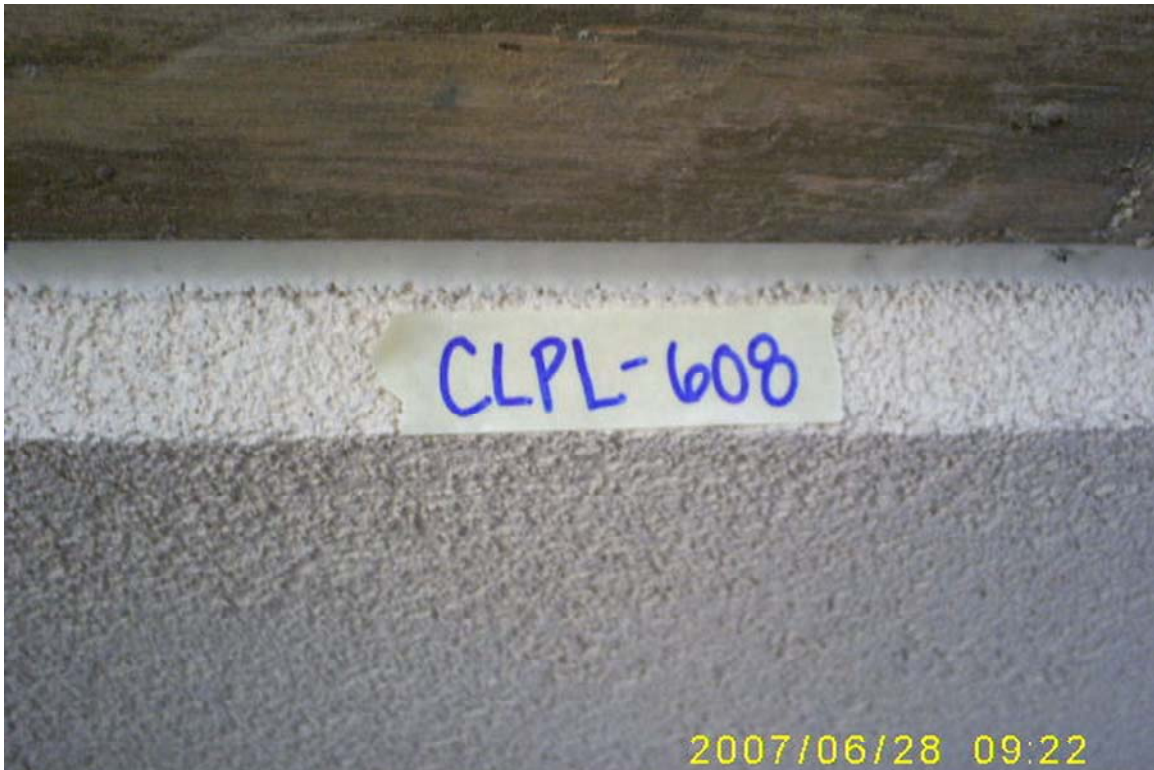
*Above: HA CLPL-608*

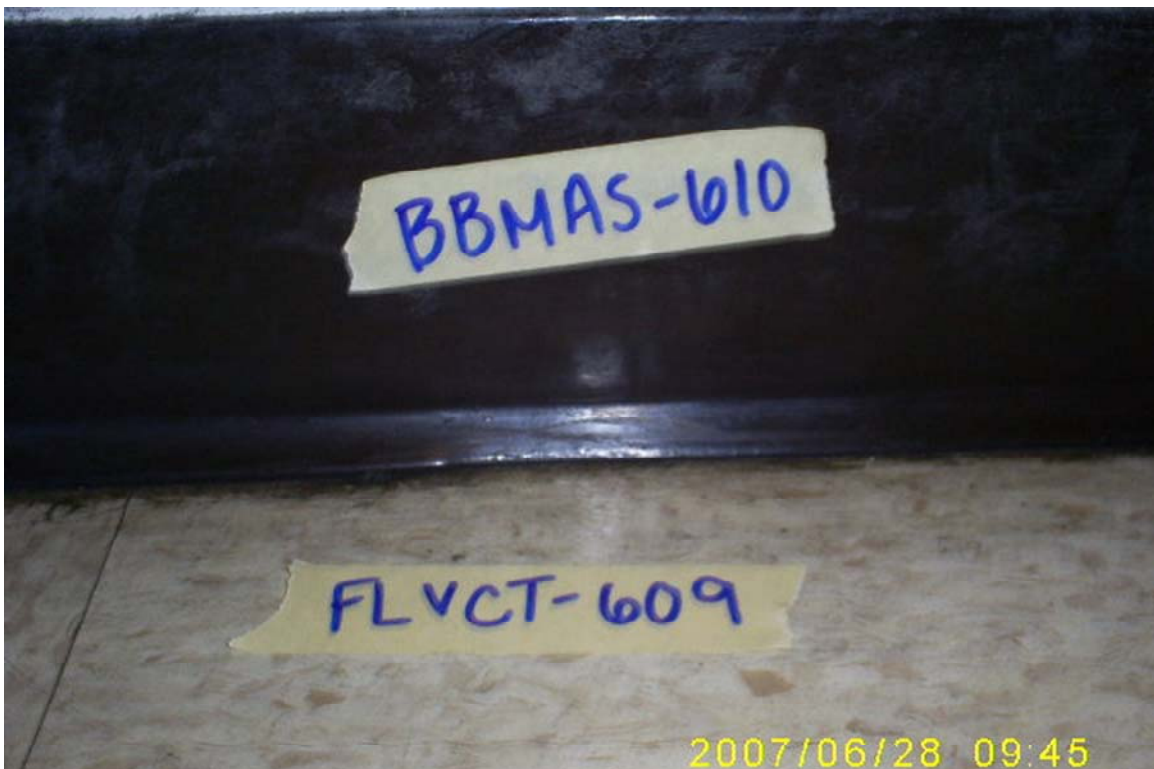
*Below: HA BBMAS-610 & FLVCT-609*

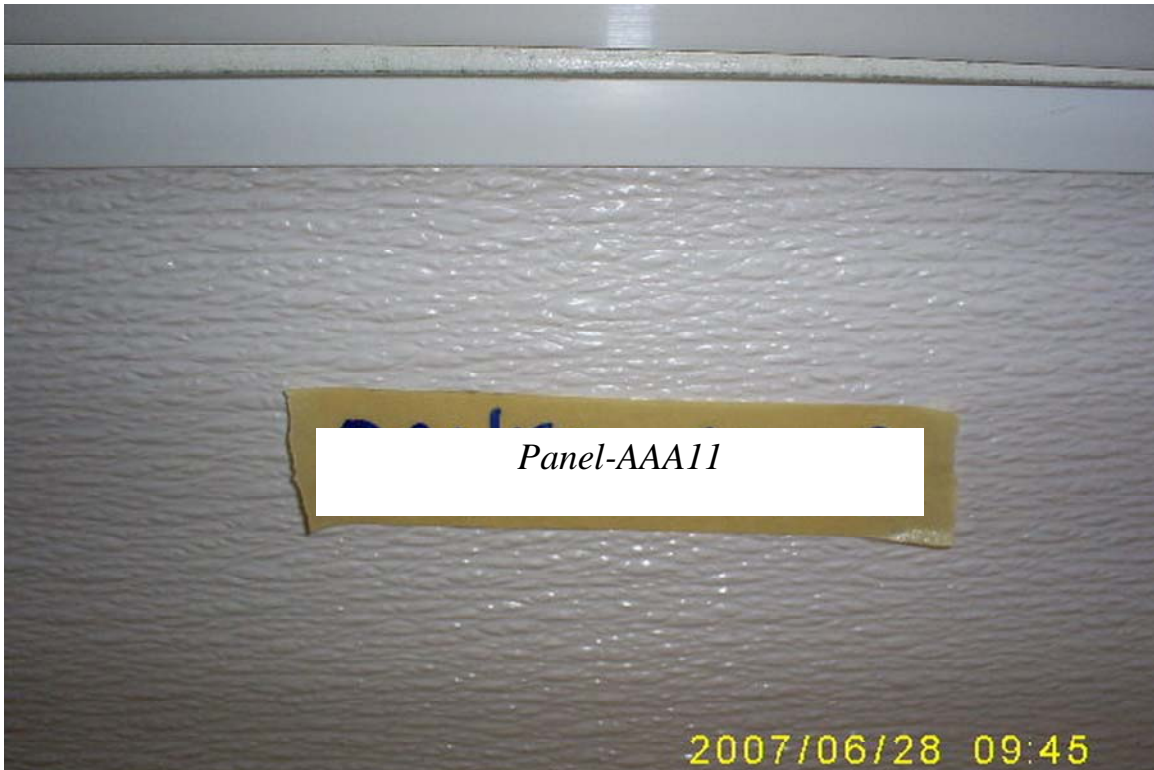
*Above: HA PANEL-AAA11*

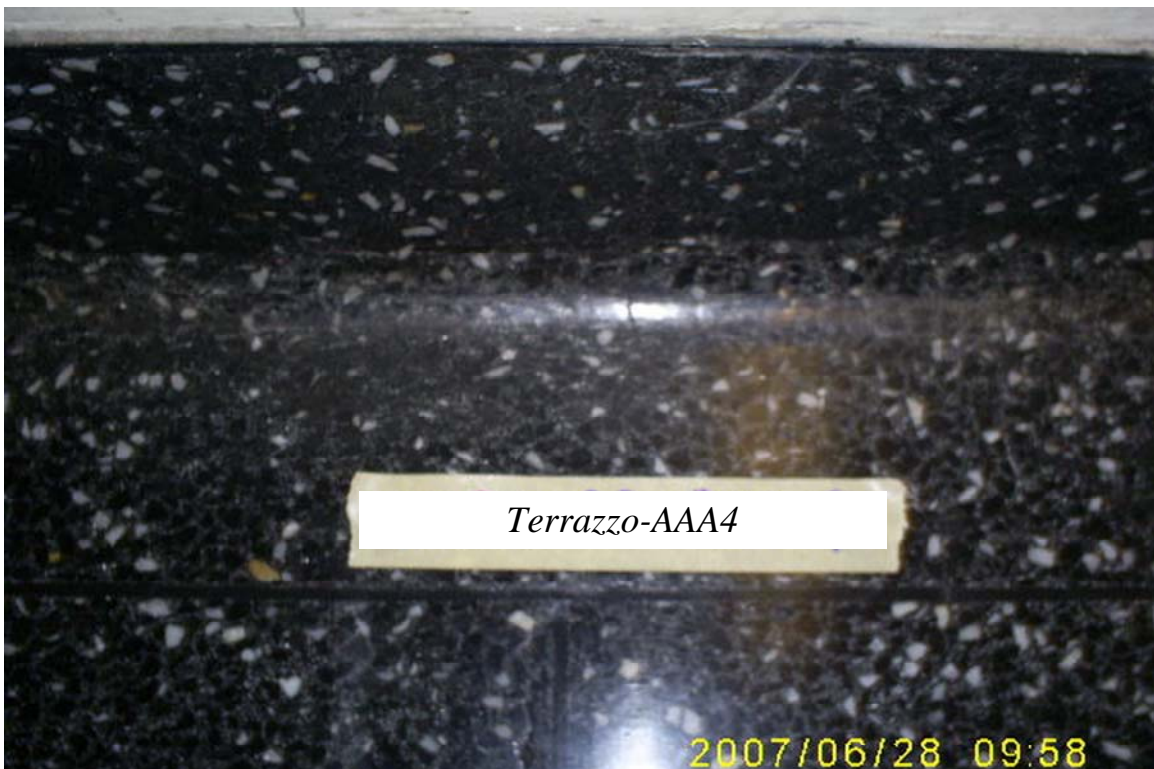
*Below: HA TERRAZZO-AAA4*

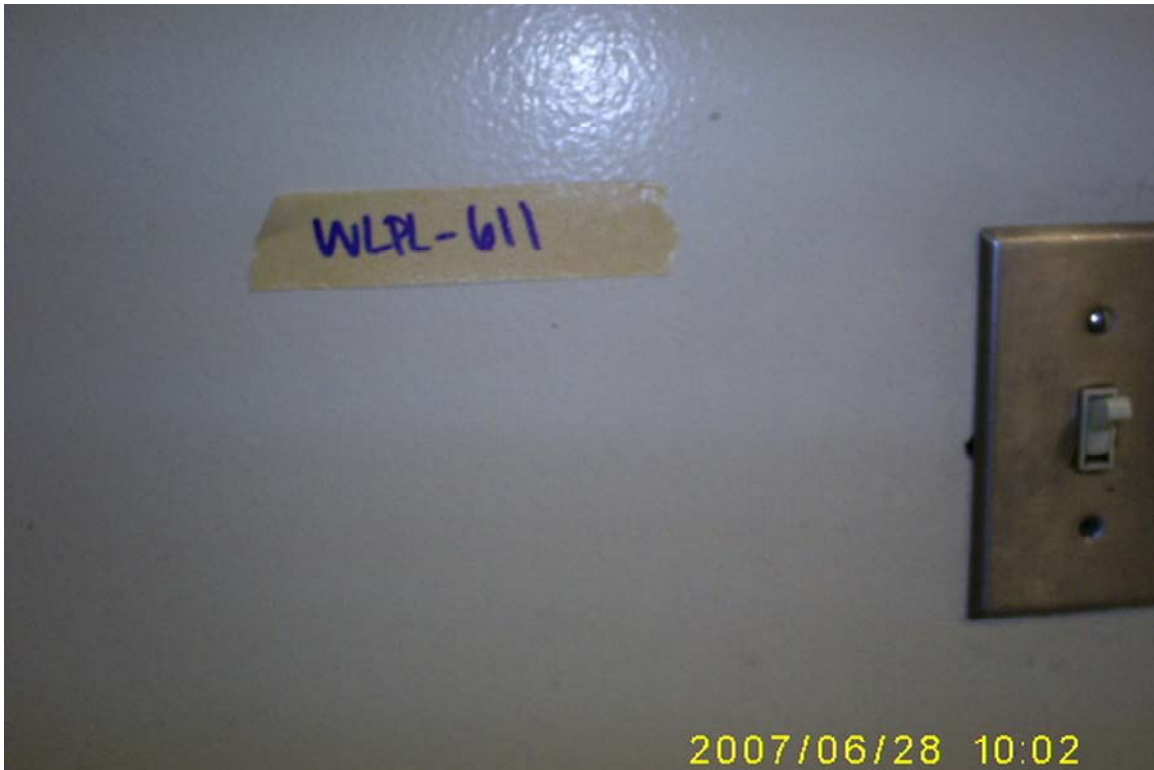
*Above: HA WLPL-611*

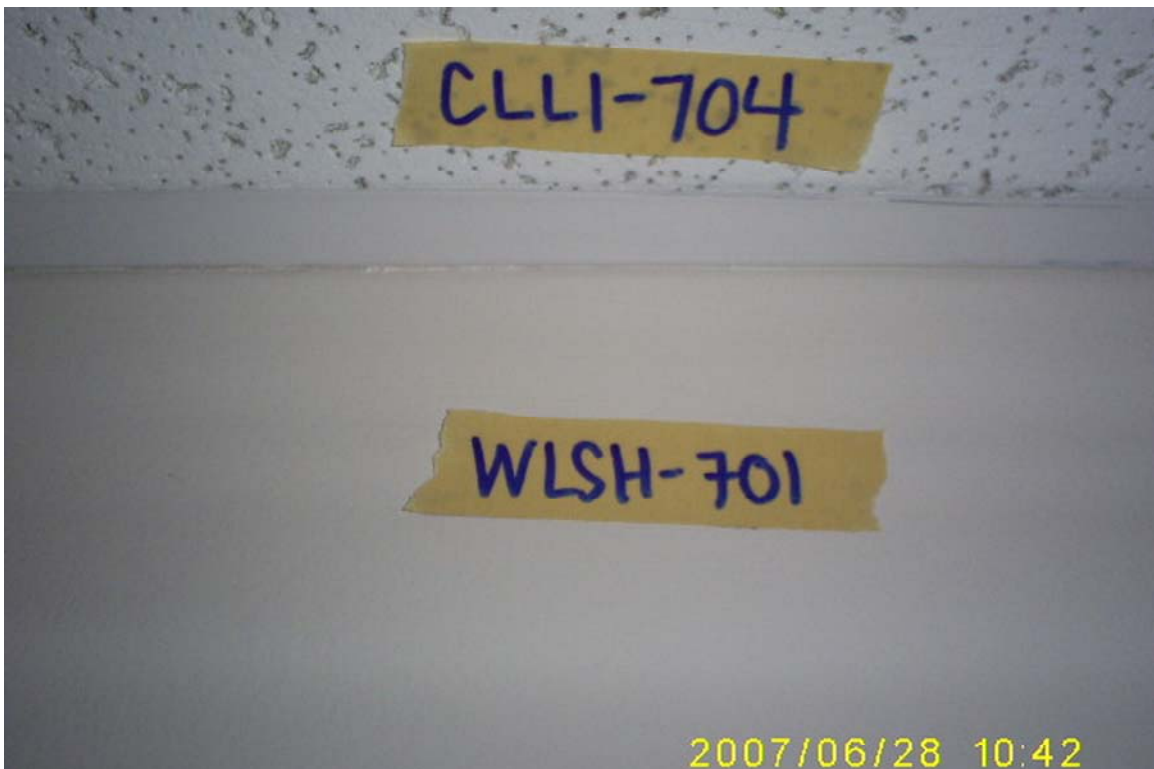
*Below: HA's CLLI-704 & WLSH-701*

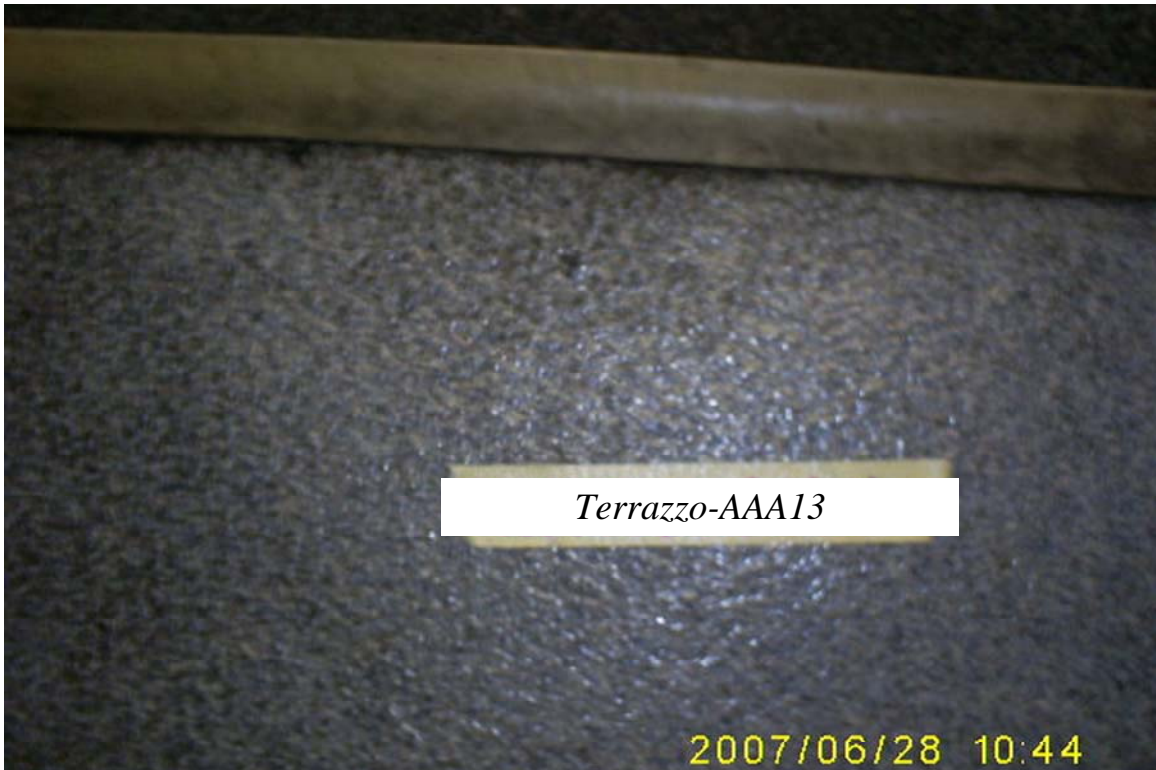
*Above: HA TERRAZZO-AAA13*

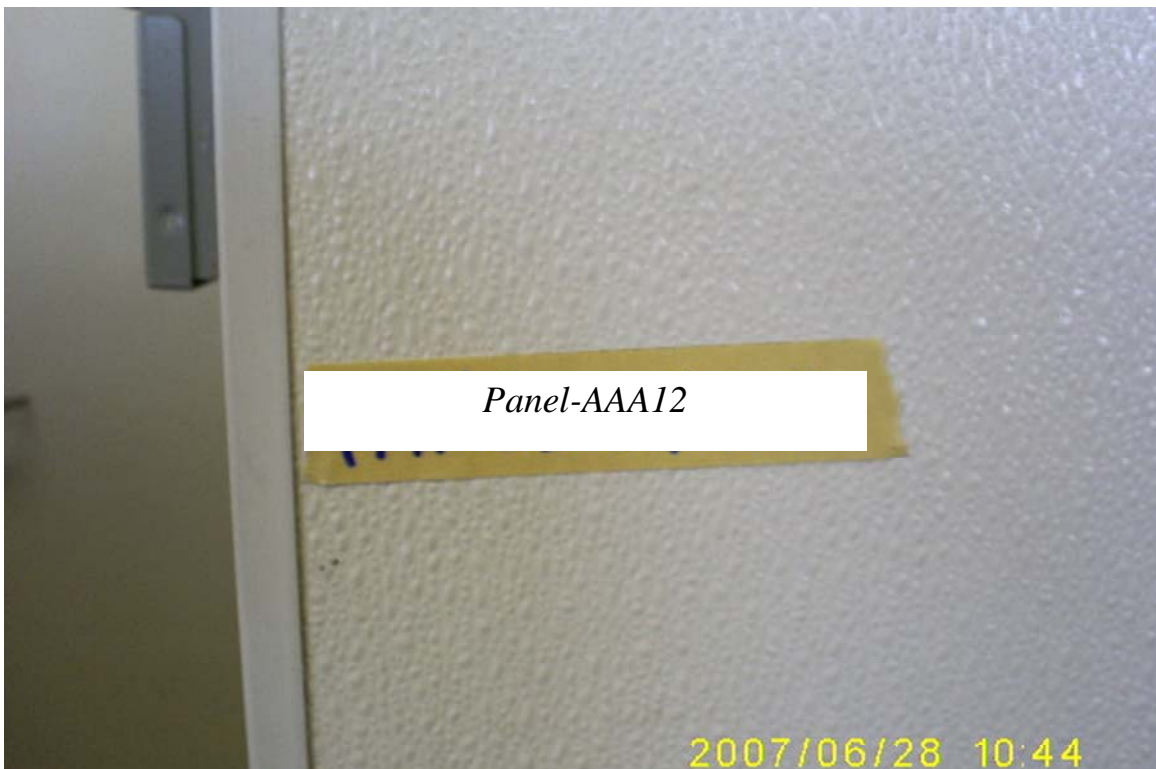
*Below: HA PANEL-AAA12*

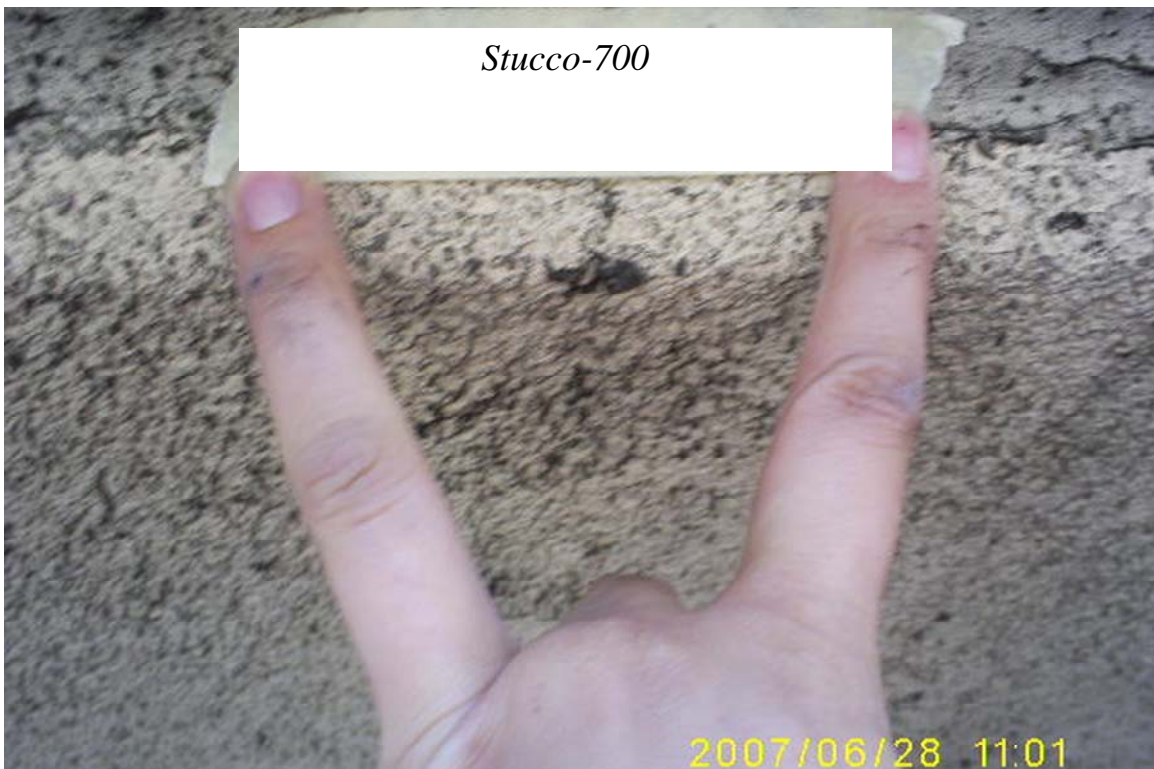
*Below: HA STUCCO-700*

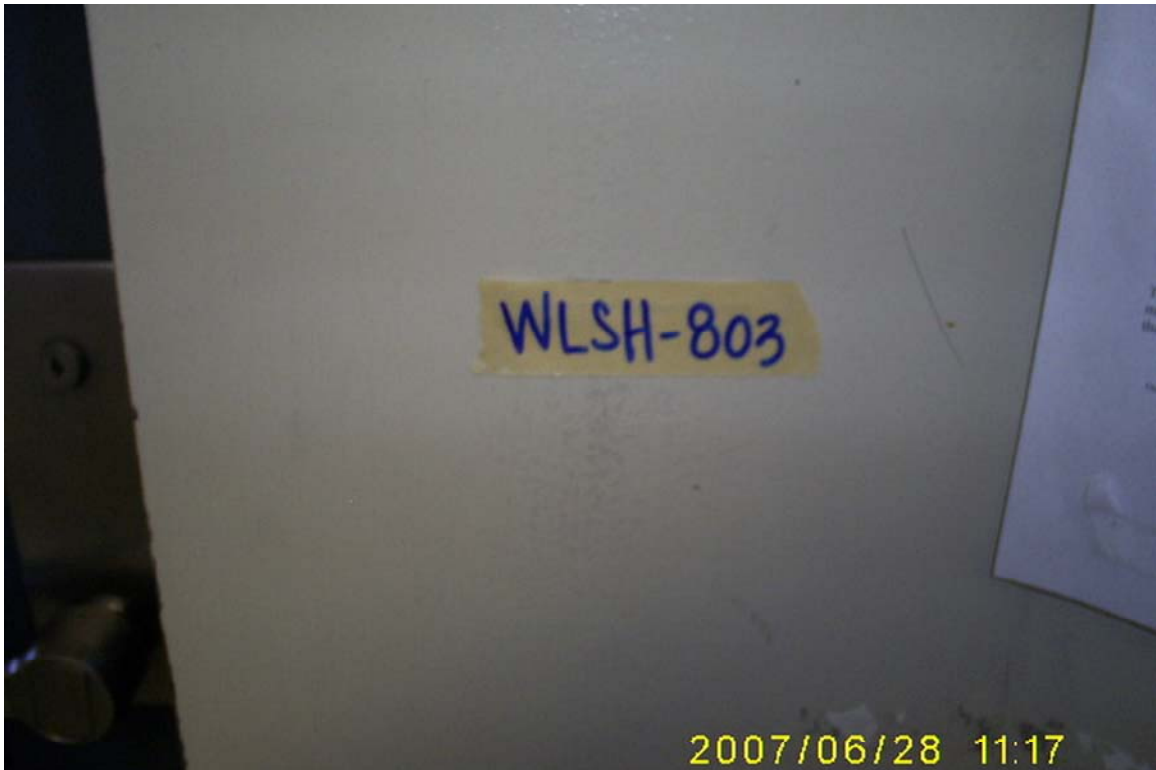
*Above: HA WLSH-803*

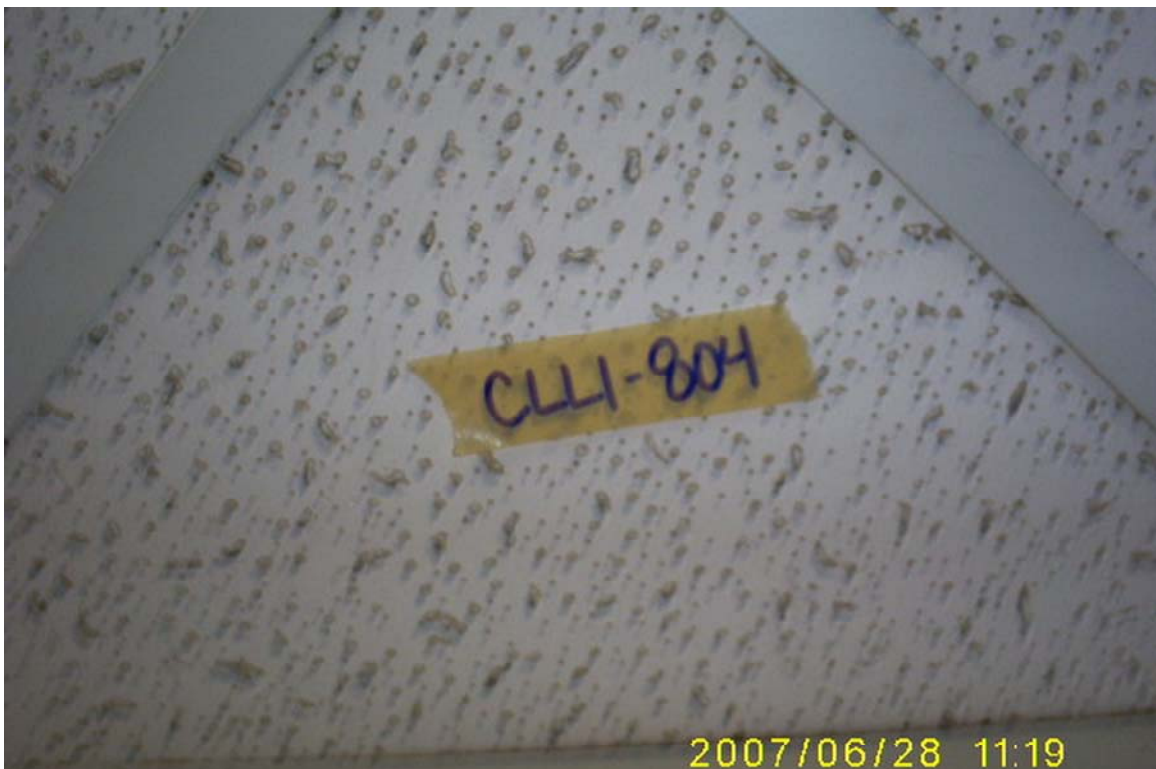
*Below: HA CLLI-804*
